HELICOPTER SUPPORTED PHOTOGRAMMETRIC SURVEY OF RAMSBERG CASTLE

Abstract

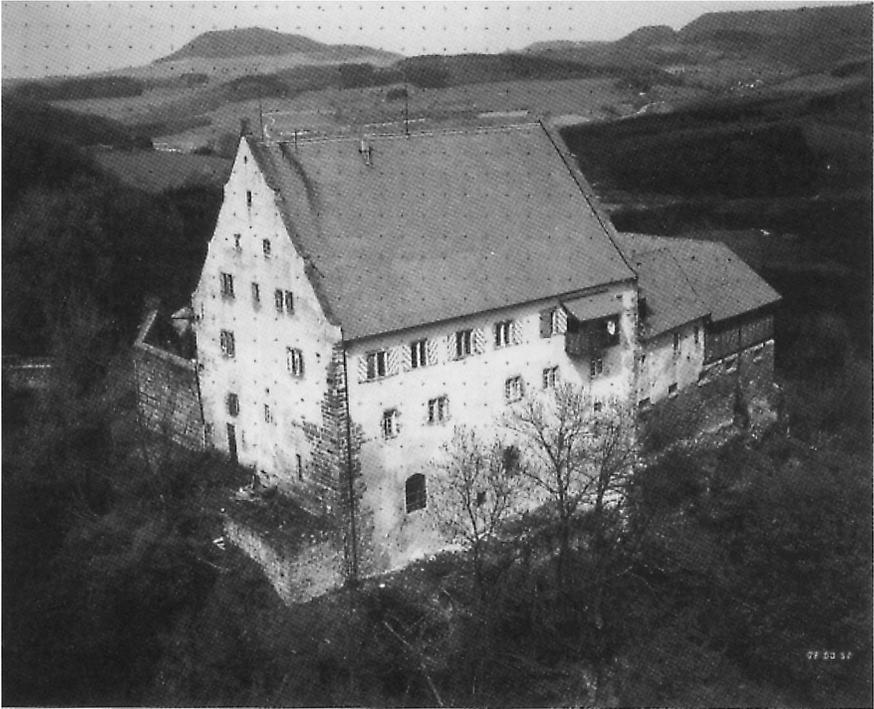
FIG. 1. Ramsberg Castle from the helicopter. The photograph was taken with a Linhof Metrika.

As described in the introduction and shown in Figs. 1 and 2, the terrain on two sides of the castle slopes steeply away, whilst on the third side is the defensive ditch immediately bordered by dense woodland. Camera stations suitable to record the façades from the ground can only be found within the courtyard. Therefore it was decided to take the survey photographs from a helicopter. The main advantages of helicopter supported photography are the short time required for taking the photographs and the excellent view provided of the site and its environs. In the case of Ramsberg Castle, a photogrammetric survey without the aid of a helicopter platform would not have been feasible. The main drawback of the method, apart from the rental costs, lies in vibrations and unexpected movements of the platform which can lead to blurred images. For this reason, a short exposure time (of the order of $1/250$ s) should be chosen.

(Fig. 1). (The camera used had a very dense réseau grid of 2.5 mm spacing required for special applications in industrial metrology but not necessary, of course, for the photogrammetric survey of the castle.)

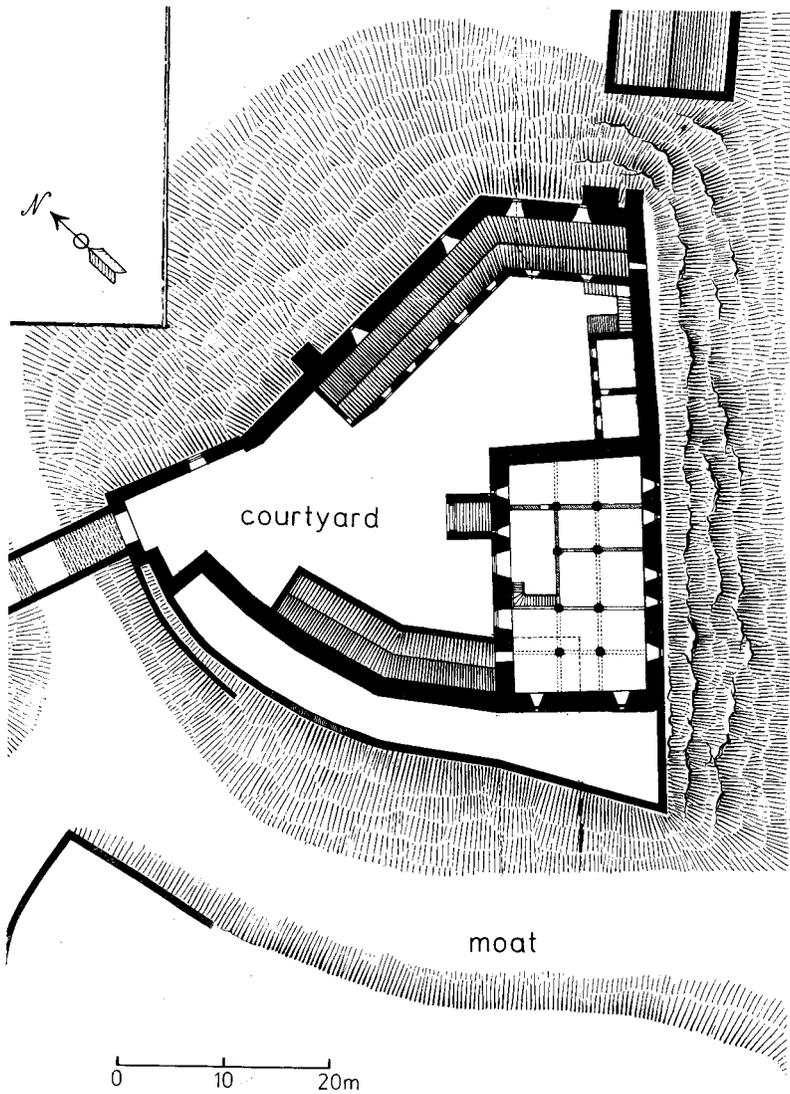
FIG. 2. A ground plan of Ramsberg Castle.

RAMSBERG CASTLE is situated on the edge of the *Schwäbische Alb* in the state of *Baden-Württemberg* in Germany. The castle complex, with a basically triangular ground plan, is built on the spur of a hill (Figs. 1 and 2) being flanked on two sides by steep slopes and on the third by a deep defensive ditch. The castle courtyard, which lies within an enclosing wall up to 2 m thick, is reached via a bridge. The castle itself was erected in the mid 13th century. The prominent residential building belongs to a later period, having been constructed around 1550 in the Renaissance style.

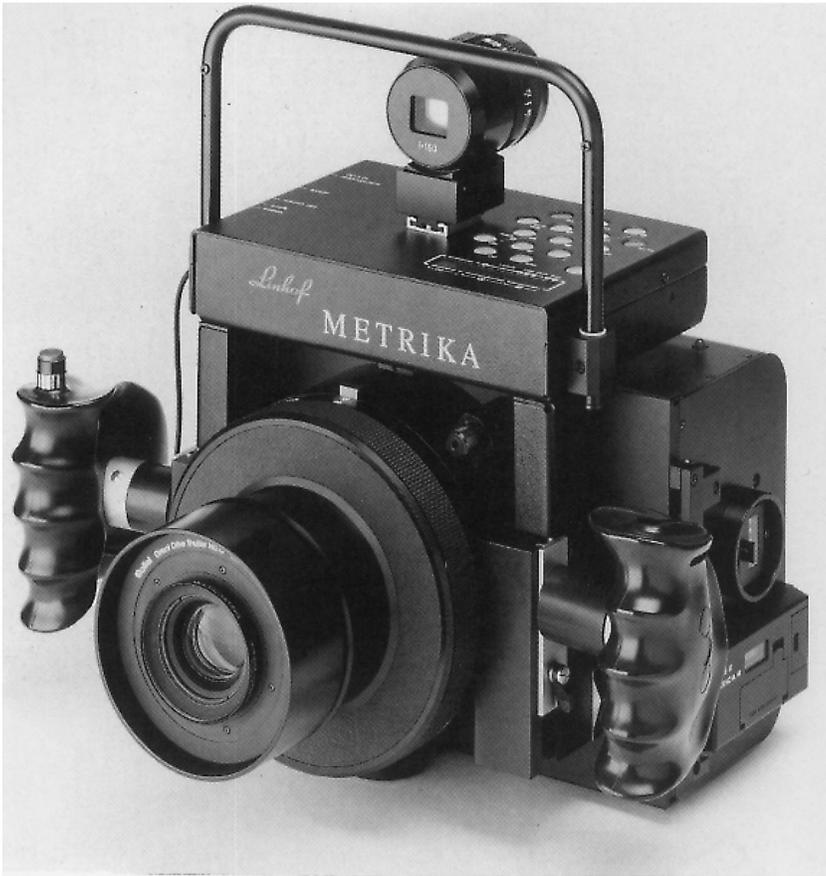
For the recording of Ramsberg Castle, a 4×5 inch Linhof Metrika (Peipe, 1990) was used. This réseau camera (Fig. 3) consists of the camera housing and an interchangeable film magazine. The housing contains the permanently mounted lens, a glass plate with grid crosses, and the electronic control and power supply unit. The standard version of the Metrika provides 9×11 réseau crosses with 10 mm spacing. The rollfilm back includes the vacuum system for film flattening, the film transport device and two daylight loading cartridges for 5 m of 126 mm black and white or colour film, equivalent to approximately 50 exposures.

FIG. 3. A Linhof Metrika with 150 mm lens.

Three lens systems are available: 75 mm and 90 mm Schneider Super Angulon wide angle lenses and 150 mm Schneider Apo Symmar normal angle lens. The focusing mount of each lens is equipped with a number of click stops. Each focusing stop defines a set of interior orientation parameters which remain stable once determined by camera calibration (Peipe, 1990).

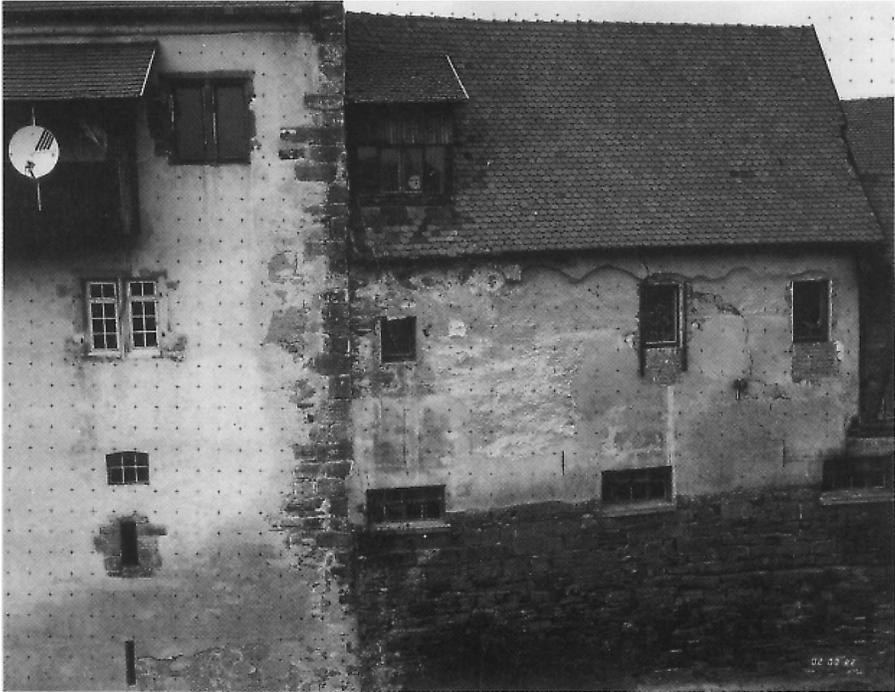
FIG. 4. A photograph of a part of the south-east façade of Ramsberg Castle.

The image block included photographs at an image scale of 1 : 200 to 1 : 300 (Fig. 4) for the stereorestitution of the façades, as well as a series of convergent photographs, partly taken from a greater distance, necessary for bundle triangulation

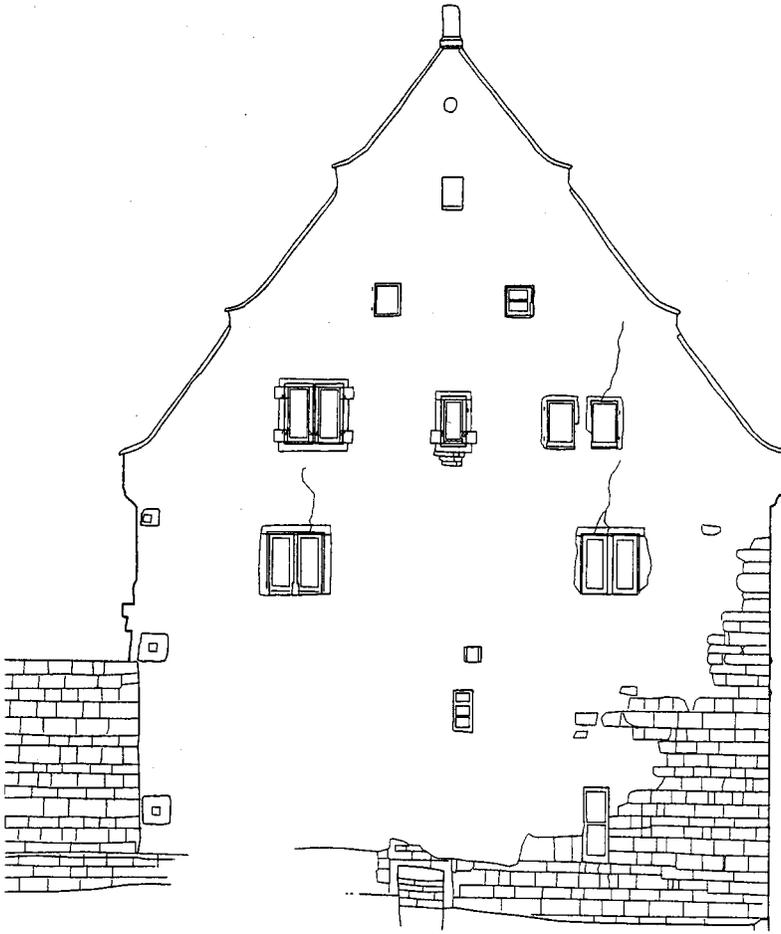
Fig. 5. A CAD plot of the south-west façade of Ramsberg Castle.

In order to document the fabric of the building and to support the further planning of renovation, photogrammetric drawings of the façades were produced from stereophotographs. The stereocompilation was carried out in a Zeiss Planicomp C100 connected with the Intergraph MicroStation PC CAD system. Plans at a scale of 1:50 were derived from the CAD model and plotted off-line using a Versatec plotter (Fig. 5).
